Inspection Report

Property Address:
1234 Anywhere Drive
Unknown AZ 98765

Veteran Inspection Professionals llc

Summary

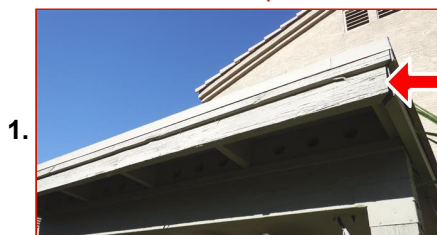
Item 1 -

Weather damaged/deteriorated fascia boards observed at the south elevation. Some repair and/or replacement is needed. Consult a qualified contractor.

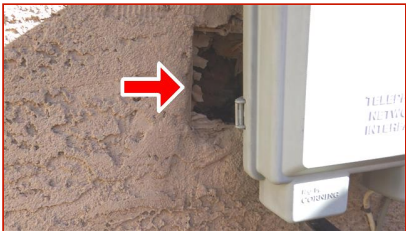
Item 2 - West Elevation

2. (1) Holes were observed in the stucco cladding at one or more areas. All holes should be repaired/sealed.

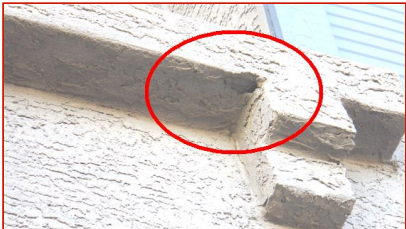
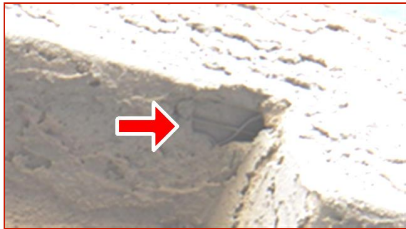
(3) Damage noted at the stucco cladding on the north elevation of the garage face. Wire mesh is exposed. A qualified person should make repairs.

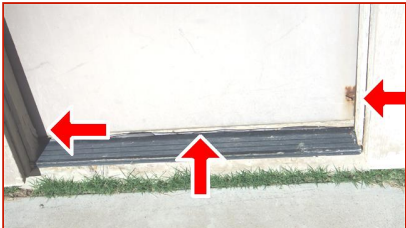
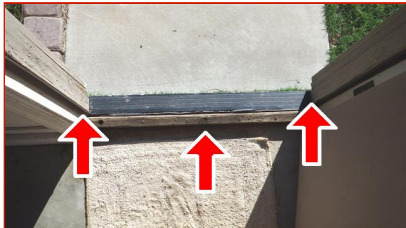
(2) The garage service door has one, or more, of the following conditions that require repair: Trim/door casing is loose and/or water damaged, Threshold is loose/water damaged, Door is delaminated/rusted, Locks not functional, Door does not close properly.

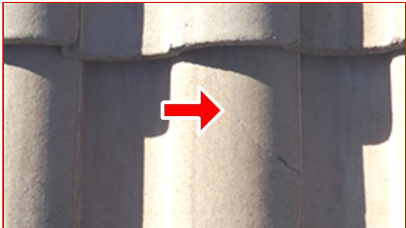
Item 5 -

(1) There is at least one cracked tile at the central field of the roof. Because the felt underlayment is potentially exposed, repairs are advised/needed. A qualified roofing technician should review the roof covers and repair/replace tiles and/or underlayment as necessary.

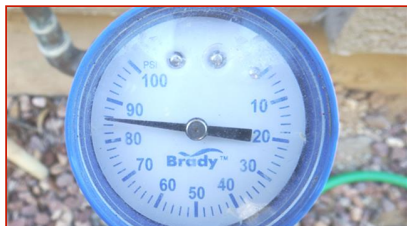
Item 6 -

System pressure (85psi), as measured by a gauge at an exterior hose bib, was excessive (above 80+). Excessive pressure can result in damage or failure to valves, seats and washers, and fixture supply lines. A qualified plumber could install an approved pressure regulator.

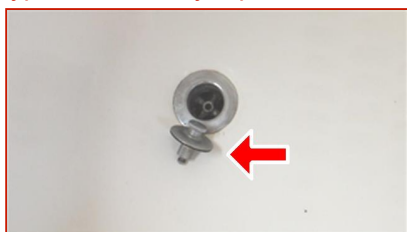
Item 7 -

(1) The master bathroom bathtub drain stop is incorrect, shaft too short, and does not function properly. This is the pop-up type that is easily replaced.

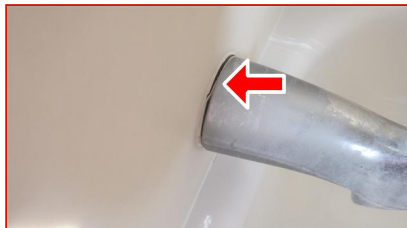
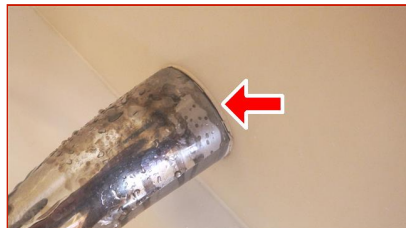
(2) There is a gap between the shower wall and the base of the tub spout in master bathroom and the upstairs guest bathroom. Water can enter the wall cavity and cause hidden damage. A qualified plumber should make required repairs.

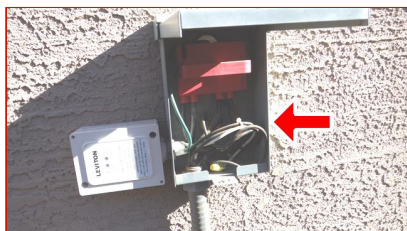
Item 9 -

The protective "deadfront" cover is missing from the HVAC disconnect service panel. The cover is needed to help to prevent hazardous shocks. The cover should be replaced by a qualified electrician.

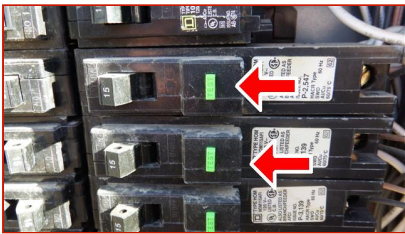
Item 10 -

Multiple Arc Fault Circuit Interrupter breakers, labeled for bedrooms, did not trip when tested at the main service panel. Replacement of the defective breakers is advised.

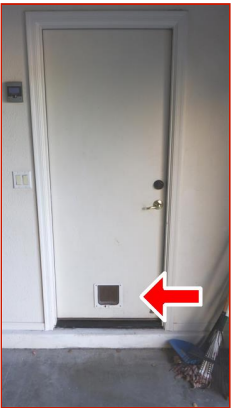
Item 11 -

There is a Pet door installed in the fire door. This is a safety defect and could cause a fire to spread quickly through the door and into the home. I recommend closing off and sealing the pet door or replacing the fire door.

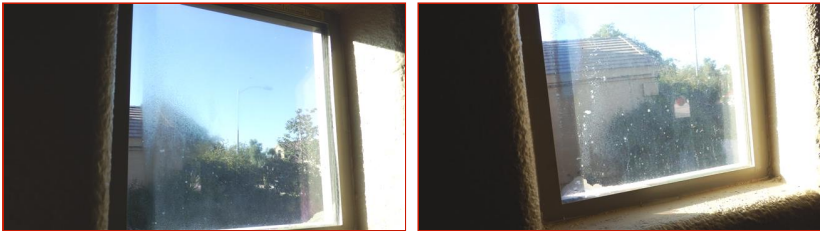
Item 12 -

(1) Condensation staining, or droplets, is present between the panes of one or more insulated glass windows in the living room. This suggests a failure of the factory seal between the twin pieces of glass. There are some companies that can repair windows with moisture between panes without replacing the window. "Fogged" windows can still perform their function for ventilation and light admittance, but can become so opaque that visibility is impaired. We did NOT attempt to list every fogged window. Have a qualified glass contractor check ALL windows and determine if the breach can be fixed or if the window needs to be replaced. Any insulated glass units which display symptoms of breached seals should be repaired or replaced as desired.

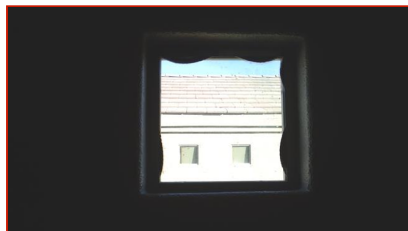
Item 13 -

(2) One or more dual pane window seals have migrated into the window glazing. While no moisture was observed between the window panes this is still an indication of a failed seal(s) and should be evaluated for repair/replacement by a qualified person.

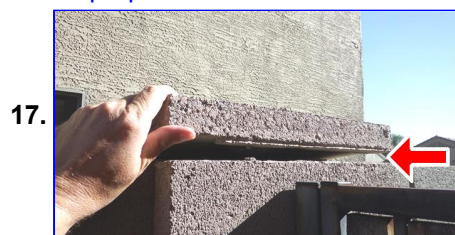
Item 17 -

Cap block(s) are loose and/or missing at one or more of the masonry block fence pilasters. Recommend repair by a qualified technician. This will be an ongoing maintenance issue for the homeowner and should be periodically checked for proper adhesion.

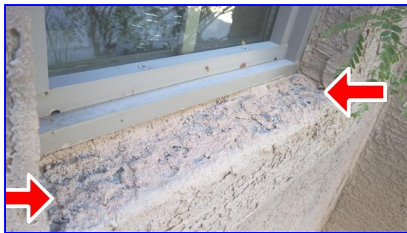
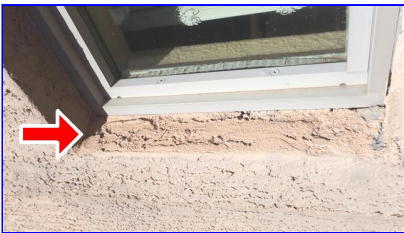
18. (2) There is evidence of deterioration in horizontal areas of the stucco around windows and along other horizontal surfaces. This could allow moisture penetration behind the stucco and/or around the window(s). Recommend repair of all horizontal surface wear in the stucco.

A prudent preventive maintenance course would be to patch and seal all horizontal stucco surfaces with a flexible urethane patching material before the next exterior paint job.

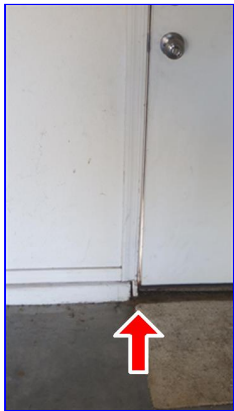
Item 19 -

(1) The weatherstripping for the garage service door is in poor condition and is not effective. To conserve energy, the weatherstripping should be repaired or replaced.

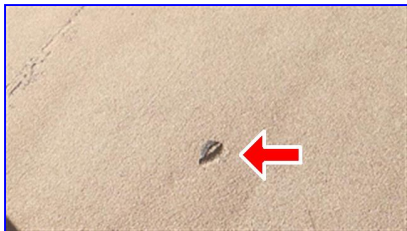
Item 20 -

(2) The torch-down roofing over the rear patio appears to have impact damage. Unable to determine if active leaks are present. A qualified roofing technician could repair.

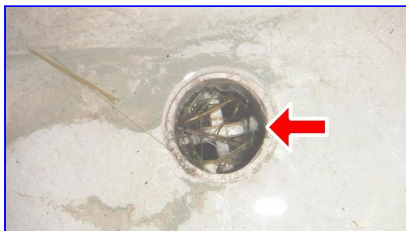
Item 21 -

The utility tub in the garage drains slowly. This appears to be due to debris in the drain grate. Recommend removal of debris to verify drainage, if this does not alleviate the problem a qualified plumbing technician could repair.

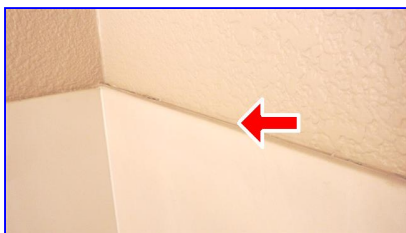
Item 22 -

Caulking/Grout at the second floor guest bathroom shower enclosure is deteriorated, cracked, and/or missing. Missing or deteriorated caulking can promote water penetration into the adjoining structure. The old caulking should be removed and re-caulked. NOTE: Treat the area as needed before re-caulking to prevent mildew from occurring.

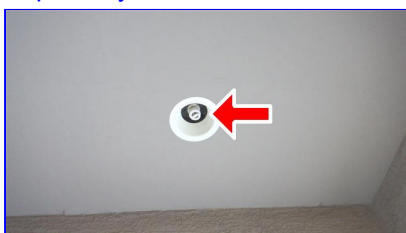
Item 23 -

The exterior light fixture(s) at the main entry porch is not functional. The bulb(s) may be burned out. The bulbs in non-functioning lights should be tested and replaced if necessary, and the proper operation of the fixtures should be verified. Repair any non-functional fixture.

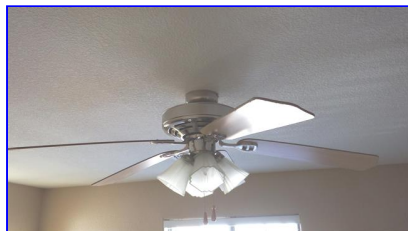
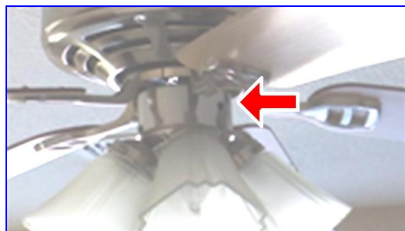
25. (2) A ceiling fan is not functional in the north guest bedroom. A qualified technician could evaluate the fan and determine what corrective action is necessary.

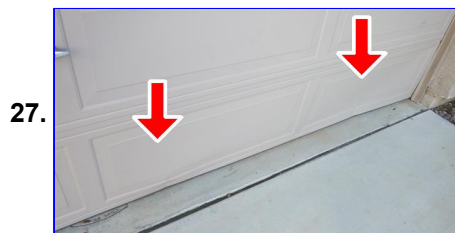
Item 27 -

(1) The garage vehicle door is dented and slightly damaged. The door was operated multiple times and no impediment to the door's operation was observed. This is a cosmetic condition that can be corrected by a qualified garage door technician.

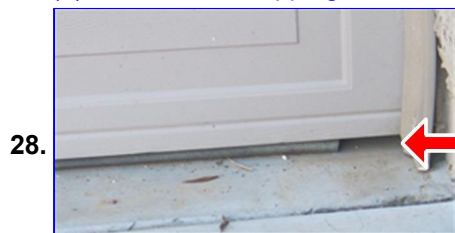
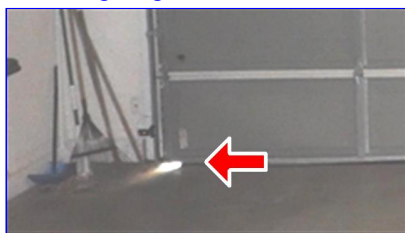
(2) The weatherstripping at the base of the garage door is insufficient. The weatherstripping should be repaired/replaced.

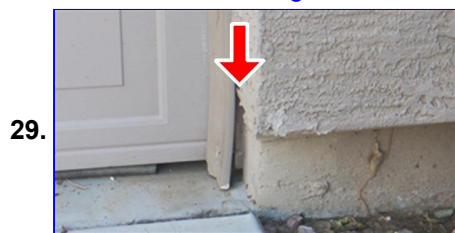
Item 29 -

(3) Portions of the trim are separating from the garage doorframe. Loose and/or missing trim should be repaired or replaced.

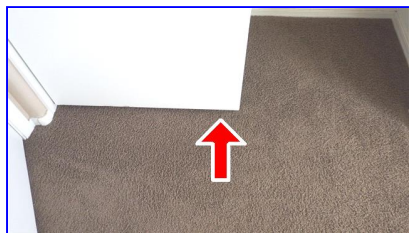
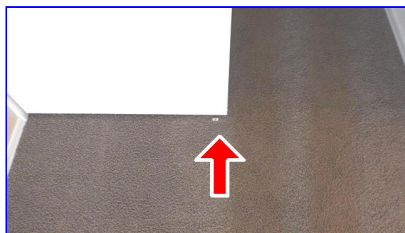
The lower guides to the bypass closet doors in the guest bedrooms are missing and/or damaged. The guides should be replaced/installed.

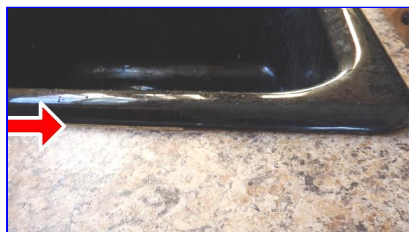
Item 32 -

Caulking at the kitchen sink perimeter is deteriorated and/or missing. This could allow water to enter into the cabinet below and cause further damage. A qualified technician should remove the old caulking and re-caulk as needed.

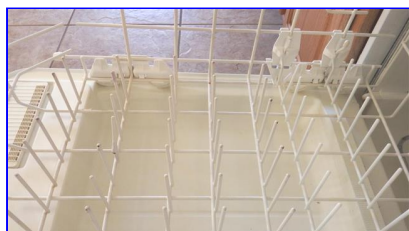
Item 33 -

One or more of the racks inside the dishwasher is corroded. Replace the corroded rack.

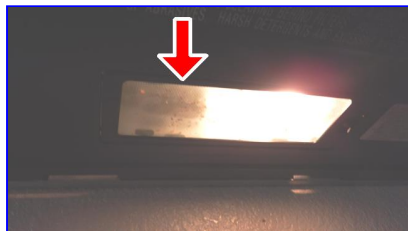
Item 34 -

34. It appears that one of the built-in cooktop light bulbs in the microwave does not illuminate. Replace the bulb to determine if the switch is defective.
