Inspection Report

Property Address:
1234 Anywhere Drive
Unknown AZ 98765

Veteran Inspection Professionals LLC

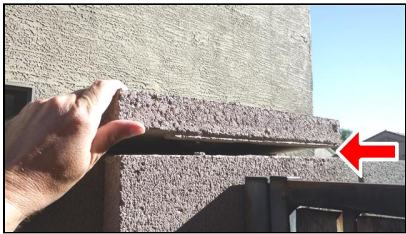
3.4

Cap block(s) are loose and/or missing at one or more of the masonry block fence pilasters. Recommend repair by a qualified technician. This will be an ongoing maintenance issue for the homeowner and should be periodically checked for proper adhesion.

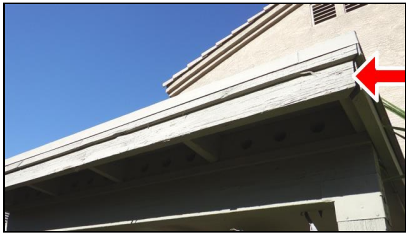
3.5

Weather damaged/deteriorated fascia boards observed at the south elevation. Some repair and/or replacement is needed. Consult a qualified contractor.

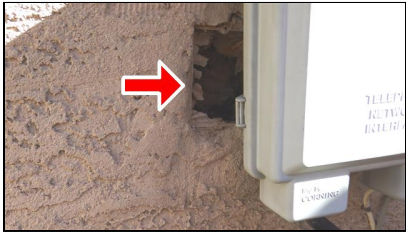
3.6 West Elevation

(1) Holes were observed in the stucco cladding at one or more areas. All holes should be repaired/ sealed.

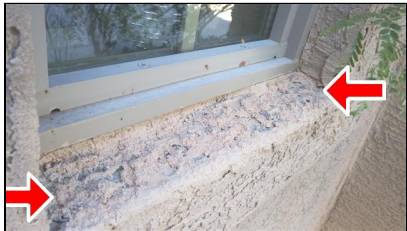
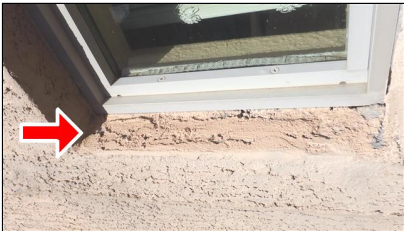
3.6

(2) There is evidence of deterioration in horizontal areas of the stucco around windows and along other horizontal surfaces. This could allow moisture penetration behind the stucco and/or around the window(s). Recommend repair of all horizontal surface wear in the stucco.

A prudent preventive maintenance course would be to patch and seal all horizontal stucco surfaces with a flexible urethane patching material before the next exterior paint job.

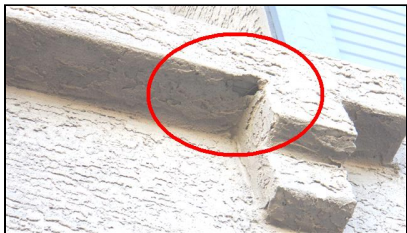
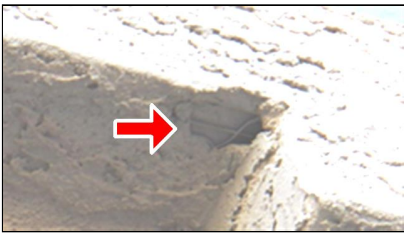
3.6

(3) Damage noted at the stucco cladding on the north elevation of the garage face. Wire mesh is exposed. A qualified person should make repairs.

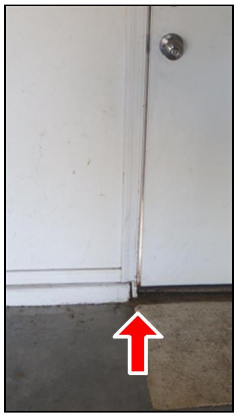
3.7

(1) The weatherstripping for the garage service door is in poor condition and is not effective. To conserve energy, the weatherstripping should be repaired or replaced.

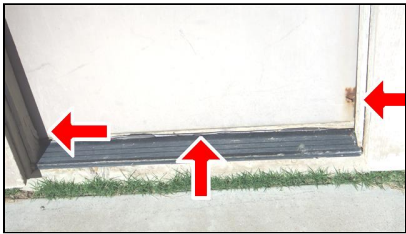
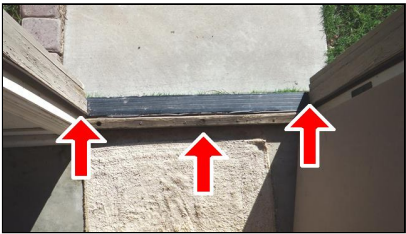
3.7

(2) The garage service door has one, or more, of the following conditions that require repair: Trim/door casing is loose and/or water damaged, Threshold is loose/water damaged, Door is delaminated/rusted, Locks not functional, Door does not close properly.

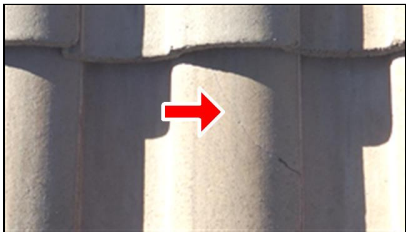
4.1

(1) There is at least one cracked tile at the central field of the roof. Because the felt underlayment is potentially exposed, repairs are advised/needed. A qualified roofing technician should review the roof covers and repair/replace tiles and/or underlayment as necessary.

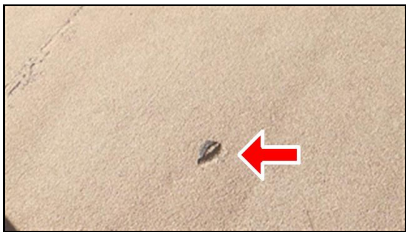
4.1

(2) The torch-down roofing over the rear patio appears to have impact damage. Unable to determine if active leaks are present. A qualified roofing technician could repair.

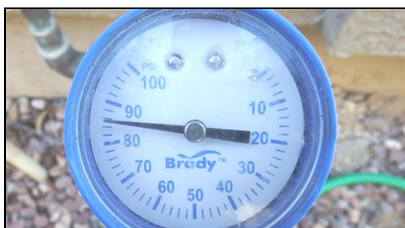
5.3

System pressure (85psi), as measured by a gauge at an exterior hose bib, was excessive (above 80+). Excessive pressure can result in damage or failure to valves, seats and washers, and fixture supply lines. A qualified plumber could install an approved pressure regulator.

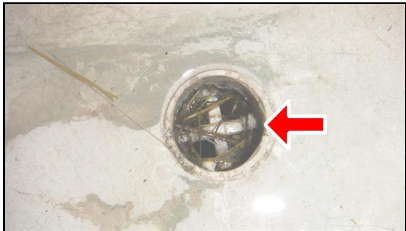
5.8

The utility tub in the garage drains slowly. This appears to be due to debris in the drain grate. Recommend removal of debris to verify drainage, if this does not alleviate the problem a qualified plumbing technician could repair.

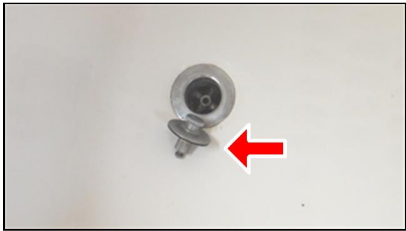
5.10

(1) The master bathroom bathtub drain stop is incorrect, shaft too short, and does not function properly. This is the pop-up type that is easily replaced.

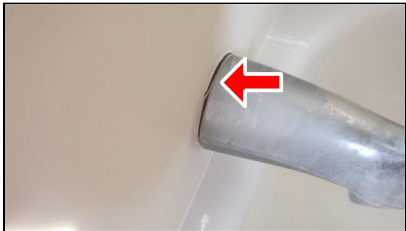
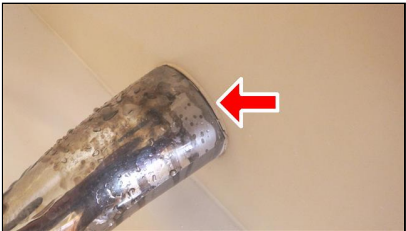
5.10

(2) There is a gap between the shower wall and the base of the tub spout in master bathroom and the upstairs guest bathroom. Water can enter the wall cavity and cause hidden damage. A qualified plumber should make required repairs.

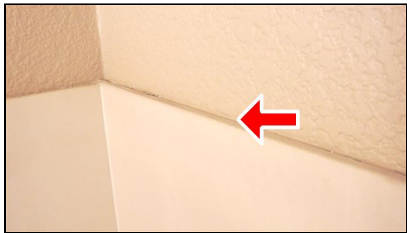
5.11

Caulking/Grout at the second floor guest bathroom shower enclosure is deteriorated, cracked, and/or missing. Missing or deteriorated caulking can promote water penetration into the adjoining structure. The old caulking should be removed and re-caulked. NOTE: Treat the area as needed before re-caulking to prevent mildew from occurring.

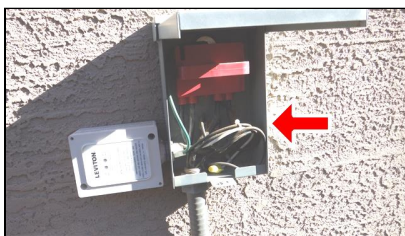
6.2

The protective "deadfront" cover is missing from the HVAC disconnect service panel. The cover is needed to help to prevent hazardous shocks. The cover should be replaced by a qualified electrician.

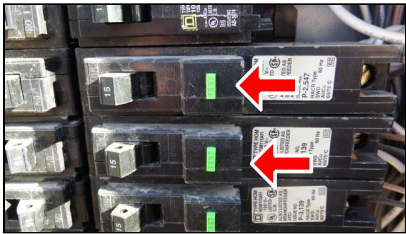
6.10

Multiple Arc Fault Circuit Interrupter breakers, labeled for bedrooms, did not trip when tested at the main service panel. Replacement of the defective breakers is advised.

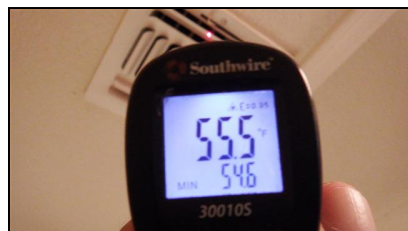
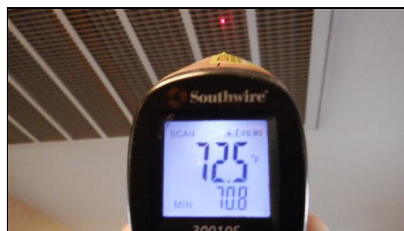
7.5

The ambient air test was performed by using thermometers on the air handler of Heat pump in cool mode to determine if the difference in temperatures of the supply and return air are between 14° and 22° which indicates that the unit is cooling as intended. The supply air temperature on your system read 55°, and the return air temperature was 72°. This indicates the range in temperature drop is normal.

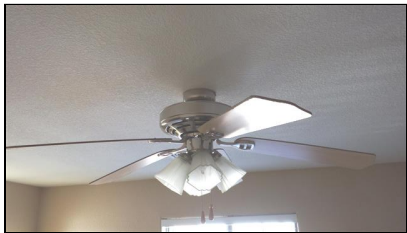
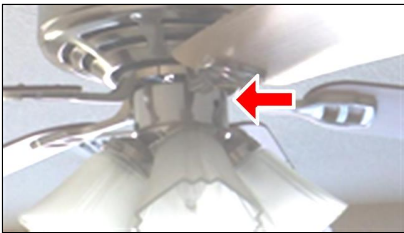
7.6

(2) A ceiling fan is not functional in the north guest bedroom. A qualified technician could evaluate the fan and determine what corrective action is necessary.

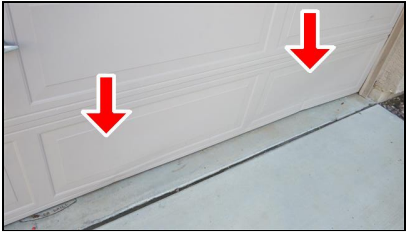
9.1

(1) The garage vehicle door is dented and slightly damaged. The door was operated multiple times and no impediment to the doors operation was observed. This is a cosmetic condition that can be corrected by a qualified garage door technician.

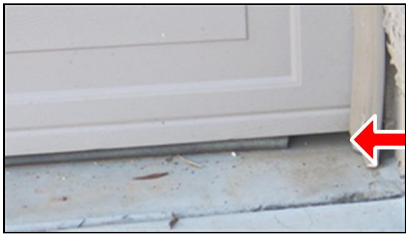
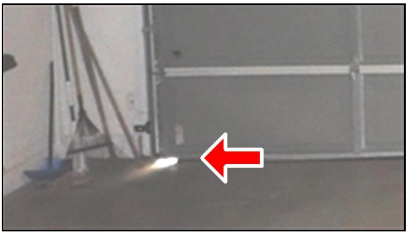
9.1

(2) The weatherstripping at the base of the garage door is insufficient. The weatherstripping should be repaired/replaced.

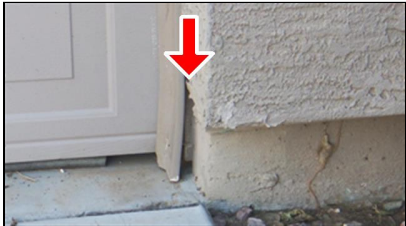
9.1

(3) Portions of the trim are separating from the garage doorframe.
Loose and/or missing trim should be repaired or replaced.

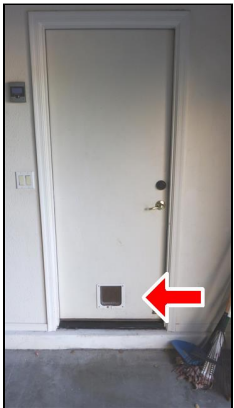
9.2

There is a Pet door installed in the fire door. This is a safety defect and could cause a fire to spread quickly through the door and into the home. I recommend closing off and sealing the pet door or replacing the fire door.

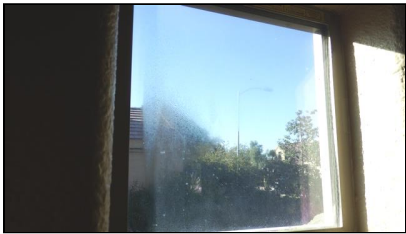
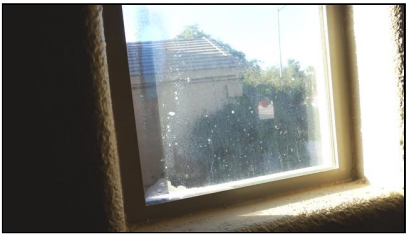
10.5

(1) Condensation staining, or droplets, is present between the panes of one or more insulated glass windows in the living room. This suggests a failure of the factory seal between the twin pieces of glass. There are some companies that can repair windows with moisture between panes without replacing the window. "Fogged" windows can still perform their function for ventilation and light admittance, but can become so opaque that visibility is impaired. We did NOT attempt to list every fogged window. Have a qualified glass contractor check ALL windows and determine if the breach can be fixed or if the window needs to be replaced. Any insulated glass units which display symptoms of breached seals should be repaired or replaced as desired.

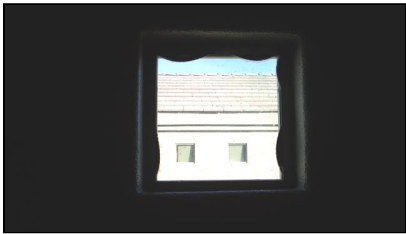
10.5

(2) One or more dual pane window seals have migrated into the window glazing. While no moisture was observed between the window panes this is still an indication of a failed seal(s) and should be evaluated for repair/replacement by a qualified person.

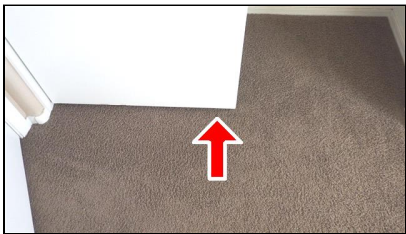
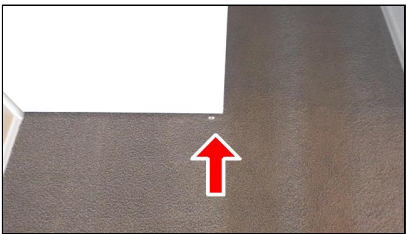
10.6

The lower guides to the bypass closet doors in the guest bedrooms are missing and/or damaged. The guides should be replaced/installed.

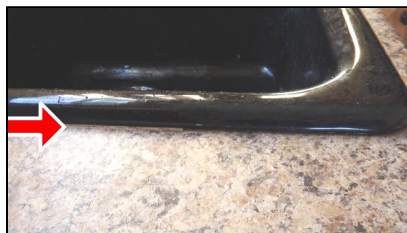
11.2

Caulking at the kitchen sink perimeter is deteriorated and/or missing. This could allow water to enter into the cabinet below and cause further damage. A qualified technician should remove the old caulking and re-caulk as needed.

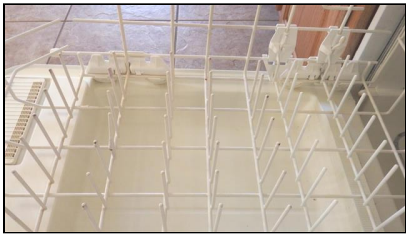
11.6

One or more of the racks inside the dishwasher is corroded. Replace the corroded rack.

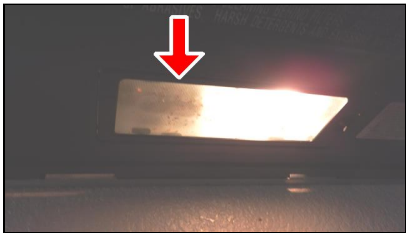
11.7

It appears that one of the built-in cooktop light bulbs in the microwave does not illuminate. Replace the bulb to determine if the switch is defective.
